Bleacher Safety Guidelines

Risk Control Strategy/ Key Issues: To provide schools and municipalities with bleacher systems a means to evaluate them.

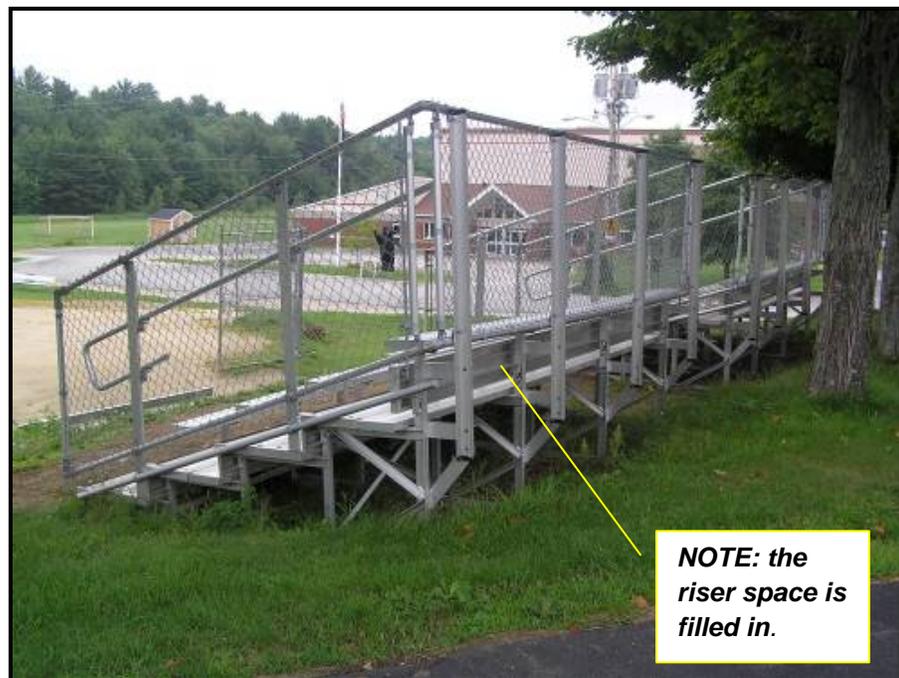
Photo shows a small, fixed or portable unit.

Note the mesh fencing on the side and back.

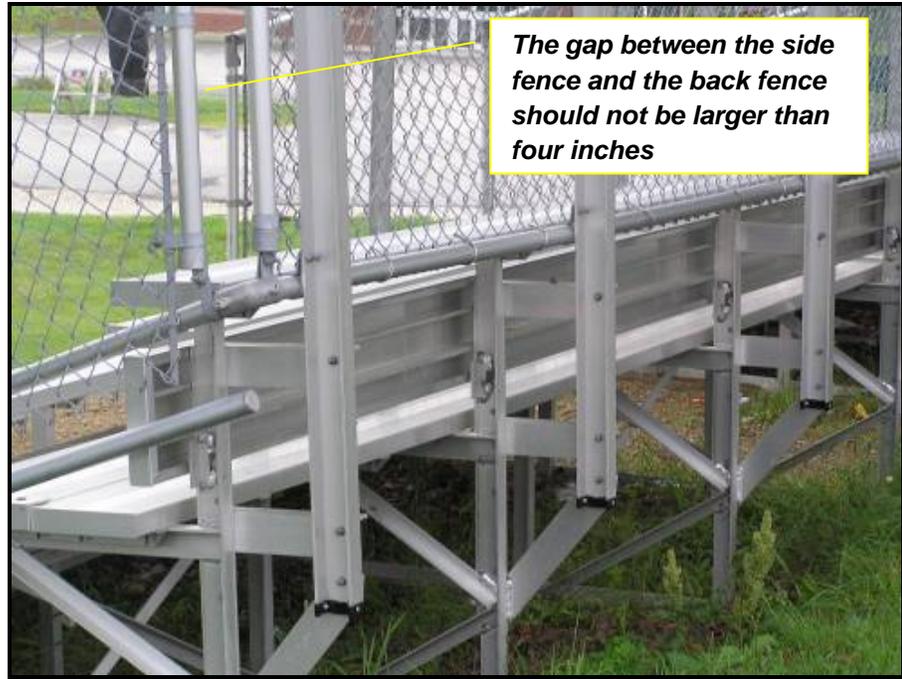
Closeup of prior photo showing the riser protection, fencing and bottom rails.

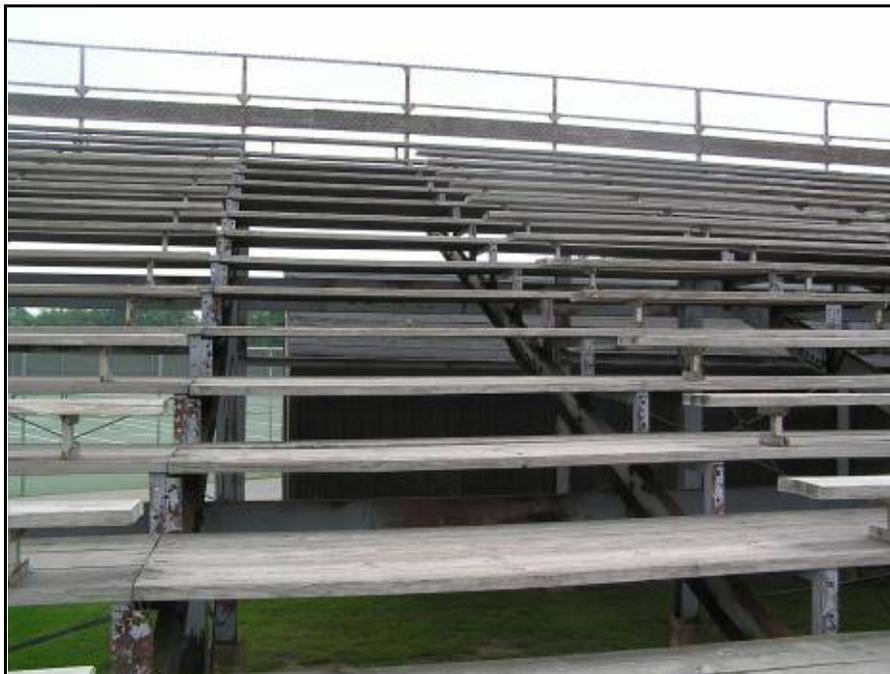
Older permanent bleacher system at a high school football field. This system has been retrofitted to some degree. There is no riser fall protection and no hand rails in the aisle walkway. However, fencing has been added to the top and sides, reducing the potential for falls from the bleachers. Riser gaps should be closed to reduce the potential for falls between the seat and walking surfaces, especially for children. The installation of aisle railings is recommended.

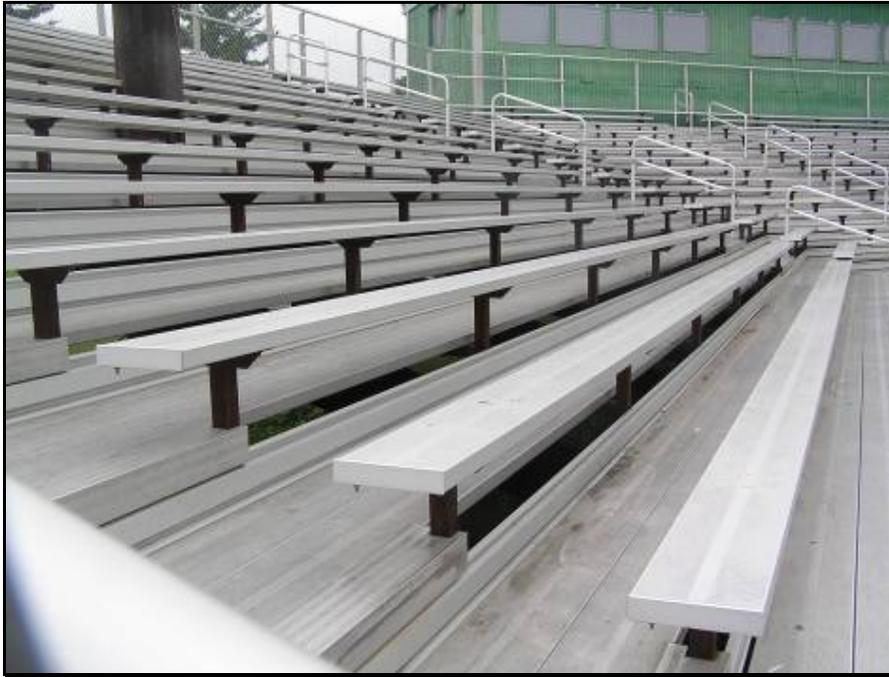
Newer permanent bleacher system at a town recreational baseball field. The system has aisle railings, riser protection, and top and side guardrails with mesh fencing. The risers should prevent falls between the seatboards and the floorboards and should also prevent objects from falling from the floorboards onto anyone beneath the bleachers.
